Ensuring Spin Test Safety

By: Eric Sonnichsen of Test Devices, Inc.
From: Mechanical Engineering, Vol115, No12
Reprinted with permission from
Mechanical Engineering magazine, ©ASME International

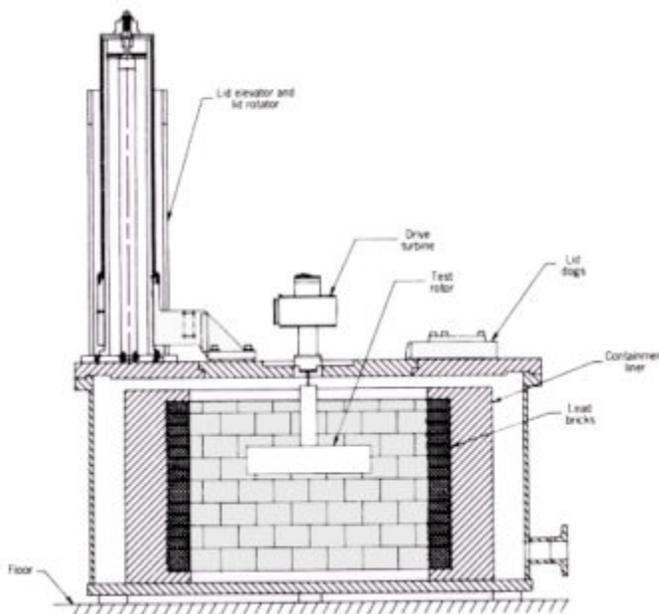
Figure 1
Spin Test Systems must be designed to contain the fragments of high-speed rotors at burst, protect users from potential injury, and save the burst fragments intact for analysis. Shown is a typical spin layout.

Since the components tested are usually spun close to failure stress, centrifugal burst is sometimes a result. Spin test systems must be designed to contain the fragments of high-speed rotors at burst, protect the users from potential injury, and save the burst fragments intact for analysis if possible.

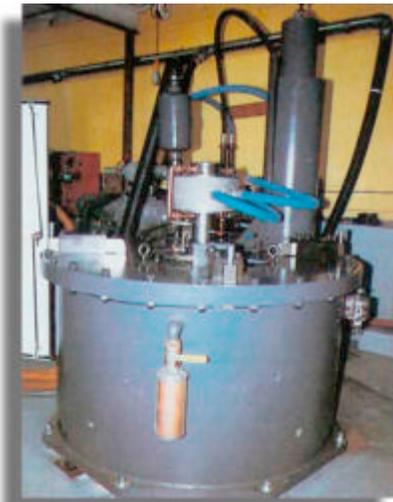
Figure 2
This 36" spin test system was used by Test Devices Inc. to burst a rotor and demonstrate that the containment structure would satisfactorily support the event (see "Anatomy of an Accident"). However, the system, which included a spin chamber, turbine - atop the pit with two blue hoses entering the side - and vacuum and oil pumps, was later destroyed in an accident.

The first reported accident of this kind occurred in early 1985. Prior to shipment, a newly manufactured system was being demonstrated by the intentional burst of a 600-pound 30-inch-diameter test rotor. The lead cushion liner impacted the cover as described earlier, fracturing the flange bolts and sending the cover, lid, and drive turbine through the ceiling of the test room (see "Anatomy of an Accident").

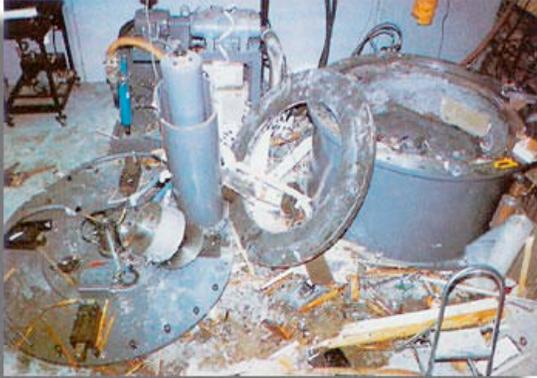
Figure 3

The spin pit cover with stripped retaining bolts is lying on the floor next to the spin chamber after the accident. The explosion destroyed the chamber and made holes in the wall and roof of the fuelling wher the experiment was being conducted.

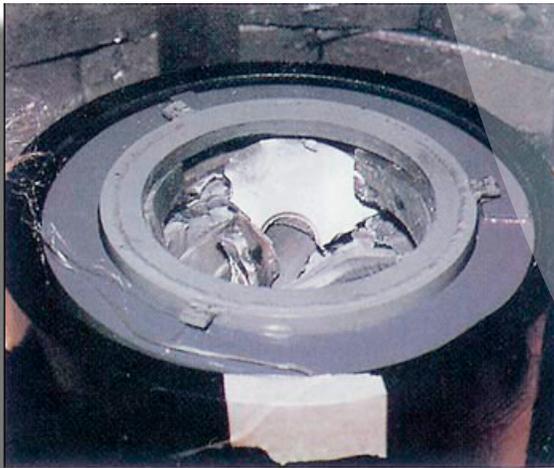
Figure 3

To solve the problem, a ledge that would cause the lead to fold back harmlessly into the pit was designed. The model spin pit inside a larger test pit is shown immediately following a lead extrusion containment burst. All the lead was contained inside the pit after the test.

The cushion extrusion problem can be addressed by the addition of ledges at the top and bottom inside surfaces of the containment cylinder, which are strong enough to withstand the peak dynamic compressive force of the cushion liner.

To prevent the impact of these bricks against the cover with subsequent cover ejection, it is necessary to add a steel brick retention ledge to the inside of the containment cylinder at both ends. This ledge must have sufficient strength to withstand a uniform axial compressive stress of 3000 psi, the maximum observed compressive strength of lead and its normal alloys. Obviously, if a material with higher compressive strength were to be used as a cushion liner, the ledge strength would have to be higher.
