Ensuring Spin Test Safety

Every Spin Test System manufacturer has had a burst containment failure in their history where things went catastrophically wrong by releasing high energy burst fragments outside of the chamber. All of these failures resulted in at least a costly repair to the spin chamber. Tragically, one containment failure of a spin test system in Europe resulted in the loss of a life. In this case, personnel were operating the equipment close by when a burst sent uncontained fragments into the surrounding area. Eric Sonnichsen, founder and Chief Technology Officer of Test Devices, published the following article in December 1993 as a public service shortly after Test Devices' own containment failure caused him to analyze the issue of spin test safety. Recognizing the potential for additional destruction and injury in the spin test industry, Mr. Sonnichsen felt manufacturers and users should be aware of the dangers and learn from our collective lack of foresight in the hope of preventing future accidents. Following his safety review, Test Devices modified its own spin test systems, and those in the field. Test Devices also instituted strict policies prohibiting operato

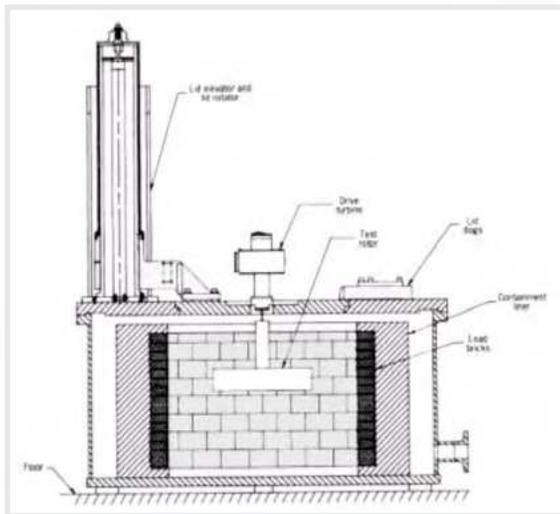
Fig. 1 – Spin Test Systems must be designed to contain the fragments of high-speed rotors at burst, protect users from potential injury, and save the burst fragments intact for analysis. Shown is a typical spin layout.

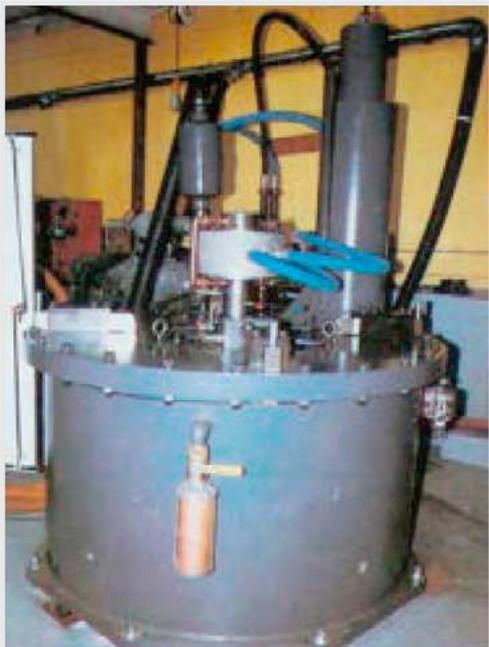
Fig. 2 – This 36" spin test system was used by Test Devices to burst a rotor and demonstrate that the containment structure would satisfactorily support the event (see "Anatomy of an Accident"). However, the system, which included a spin chamber, turbine - atop the pit with two blue hoses entering the side - and vacuum and oil pumps, was later destroyed in an accident.

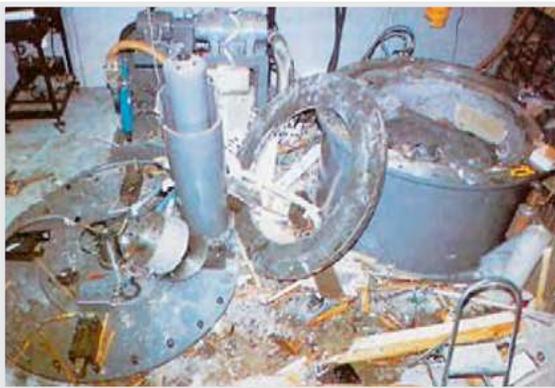
Fig. 3 – The spin pit cover with stripped retaining bolts is lying on the floor next to the spin chamber after the accident. The explosion destroyed the chamber and made holes in the wall and roof of the building where the experiment was being conducted.

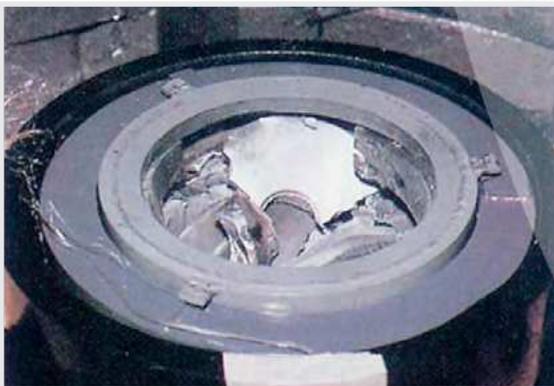
Fig. 3 – To solve the problem, a ledge that would cause the lead to fold back harmlessly into the pit was designed. The model spin pit inside a larger test pit is shown immediately following a lead extrusion containment burst. All the lead was contained inside the pit after the test.

The lead bricks typically used as an inner liner can transfer very large forces to the chamber cover when impacted by rotor burst fragments. The impact force is significantly larger than typical cover flange bolt strength and can easily blow the cover off the chamber.

To prevent the impact of these bricks against the cover with subsequent cover ejection, it is necessary to add a steel brick retention ledge to the inside of the containment cylinder at both ends. This ledge must have sufficient strength to withstand a uniform axial compressive stress of 3000 psi, the maximum observed compressive strength of lead and its normal alloys. Obviously, if a material with higher compressive strength were to be used as a cushion liner, the ledge strength would have to be higher.
