Ensuring Spin Test Safety

By: Eric Sonnichsen of Test Devices, Inc.
From: Mechanical Engineering, Vol115, No12
Reprinted with permission from
Mechanical Engineering magazine, ©ASME International

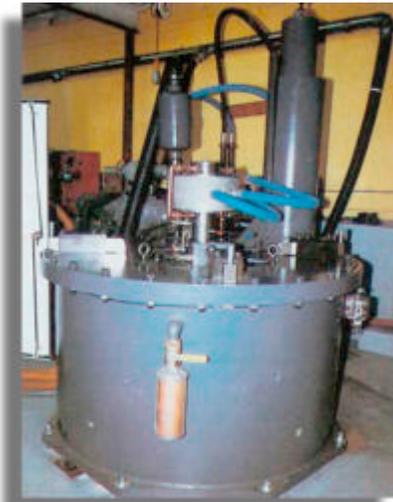
Figure 2
This 36" spin test system was used by Test Devices Inc. to burst a rotor and demonstrate that the containment structure would satisfactorily support the event (see "Anatomy of an Accident"). However, the system, which included a spin chamber, turbine - atop the pit with two blue hoses entering the side - and vacuum and oil pumps, was later destroyed in an accident.

The first reported accident of this kind occurred in early 1985. Prior to shipment, a newly manufactured system was being demonstrated by the intentional burst of a 600-pound 30-inch-diameter test rotor. The lead cushion liner impacted the cover as described earlier, fracturing the flange bolts and sending the cover, lid, and drive turbine through the ceiling of the test room (see "Anatomy of an Accident").
