Test Devices by SCHENCK

Ensuring Spin Test Safety

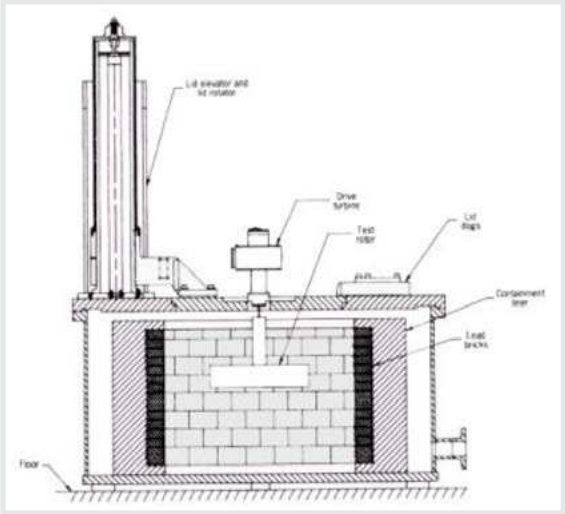
Fig. 1 – Spin Test Systems must be designed to contain the fragments of high-speed rotors at burst, protect users from potential injury, and save the burst fragments intact for analysis. Shown is a typical spin layout.

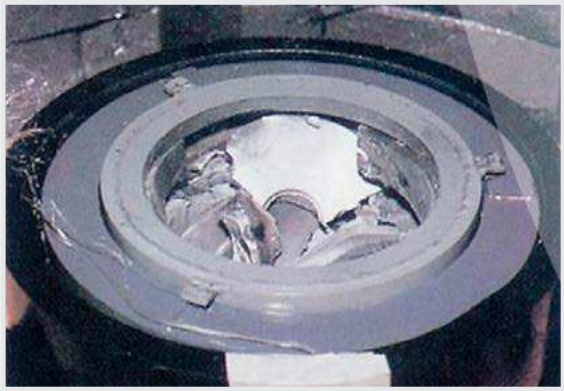
The impact of large-area high-energy burst fragments against the soft liner can expand the liner axially, driving the entire volume of cushion liner simultaneously against the base and cover of the vacuum chamber. This exerts a force equal to the dynamic compressive strength of the soft material times its projected area. This force can be several million pounds, enough to fracture the spin pit cover flange bolts.

The lead bricks typically used as an inner liner can transfer very large forces to the chamber cover when impacted by rotor burst fragments. The impact force is significantly larger than typical cover flange bolt strength and can easily blow the cover off the chamber.

Fig. 3 — To solve the problem, a ledge that would cause the lead to fold back harmlessly into the pit was designed. The model spin pit inside a larger test pit is shown immediately following a lead extrusion containment burst. All the lead was contained inside the pit after the test.

To prevent the impact of these bricks against the cover with subsequent cover ejection, it is necessary to add a steel brick retention ledge to the inside of the containment cylinder at both ends. This ledge must have sufficient strength to withstand a uniform axial compressive stress of 3000 psi, the maximum observed compressive strength of lead and its normal alloys. Obviously, if a material with higher compressive strength were to be used as a cushion liner, the ledge strength would have to be higher.
